The Quarterly Newsletter of Inspired Bridge Technologies

July 2009, Volume 7

QUAKE INCREASES WORLD RECORD SPAN

I-35W Bridge Replacement, With an Ounce of Prevention

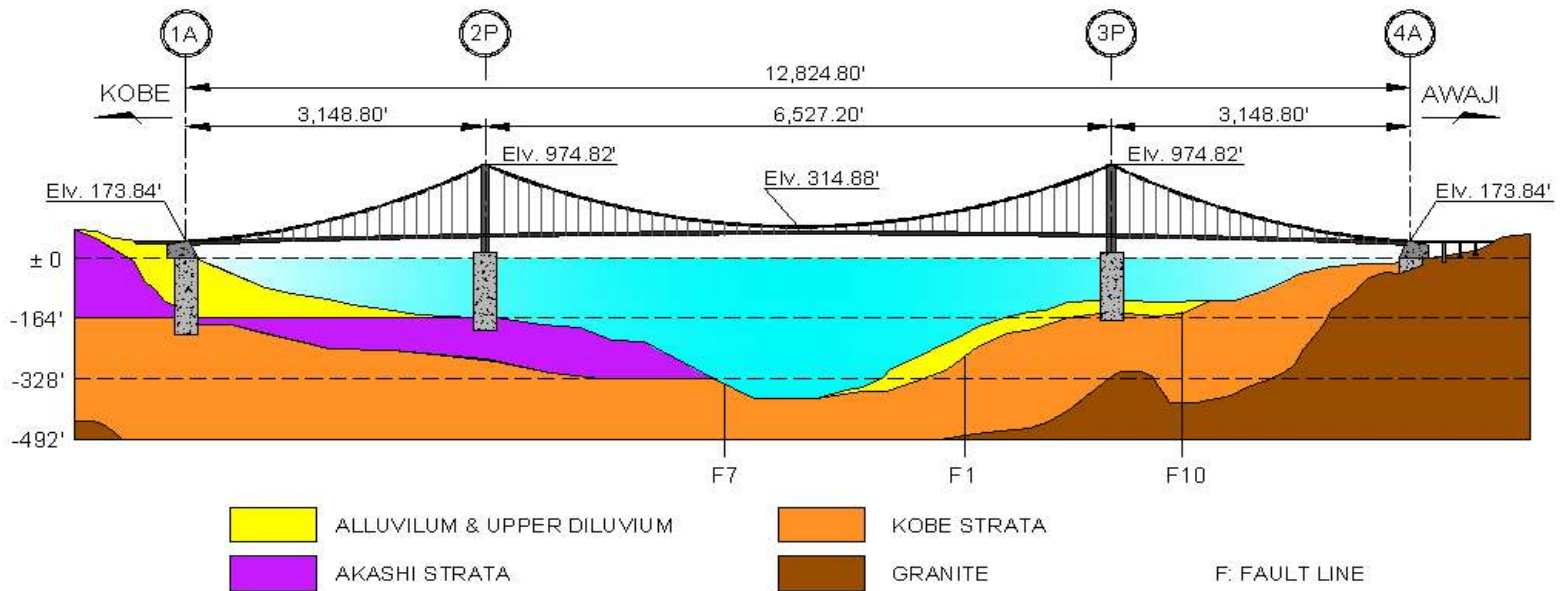
FIGURE 1: Pier 3P positioned to avoid active faults F1 & F10 and its companion pier 2P location minimizes construction depths

The geologic and hydraulic profiles at the existing bridge alignment are depicted in Figure 1 along with active fault lines F1, F7 and F10. Pier 3P was specifically positioned to avoid faults F1 and F10 and, due to the exceptionally deep midstream water, Pier 2P was located on the far, opposite side of the underwater valley to minimize water depths and facilitate underwater construction. Coincidentally, these pier locations easily exceeded the specified navigational width of 1490'. The span lengths evolving were obviously in a range never before encountered and it was recognized that the

The ideal bearing material of granite was located at an elevation exceeding the practical reach for three of the four foundations; consequently, Pier 2P was founded in the higher Akashi strata of unconsolidated gravel from the Pliocene epoch. Two bearing points, 1A and 3P, on either side of 2P, were carried to the Akashi Strata, dating from the thick soft rock of the Kobe strata dating from the Miocene epoch and the ideal bearing material of granite rose to the surface only at the 4A anchorage.

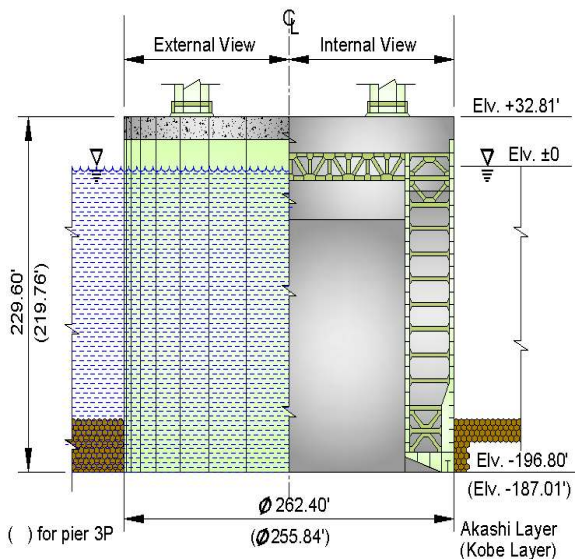
FIGURE 2: Prefabricated caisson for pier 2P

Consider, each of the main piers (2P & 3P) deliver 132,000 short tons of reaction to their bearing strata and to construct piers in these deep, swift, tidal currents (8.7 knots) special, cylindrical, prefabricated, steel caissons were used. They each weighed 16,500 short tons, measured 262.4' in diameter, and were 229.6 feet in height maximum. An array of tug-boats towed them from the dry-dock to their specified locations where they were flooded with sea water and the encompassed footprint of one and a quarter acres was lowered to the prepared sea bed and leveled to within an elevation tolerance of

no more than $-3.7''$. Once the caissons were firmly positioned three stages of concrete were placed: first, the largest, displaced the seawater; the second acted as a seal and the third provided a pier cap, all of which combined for a total of 346,000 cubic yards per pier (Figure 2).

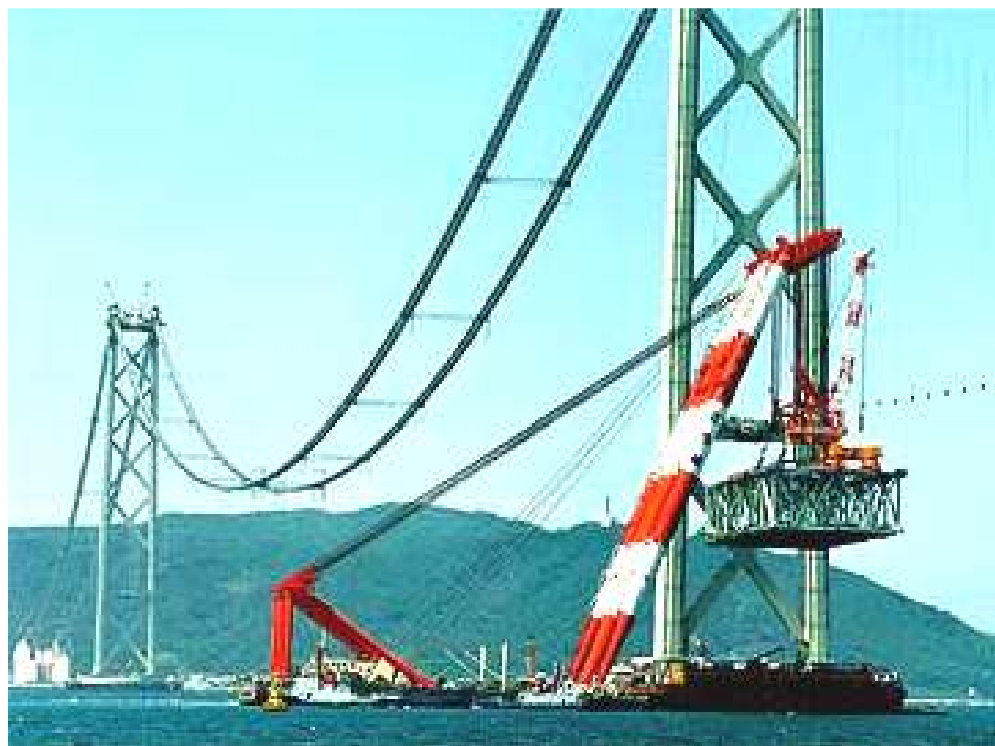
FIGURE 3: Limber configuration at time of '95 Kobe quake minimized impact

Even though the AKB was designed for an 8.5 Richter event and the 7.2 Kobe quake had its epicenter within 2.5 miles of the bridge, very little damage was incurred by the bridge because its construction state presented a very flexible target (Figure 3). The foundations and anchorages were in place and the 98 story towers were at their full height with the 50,000 short

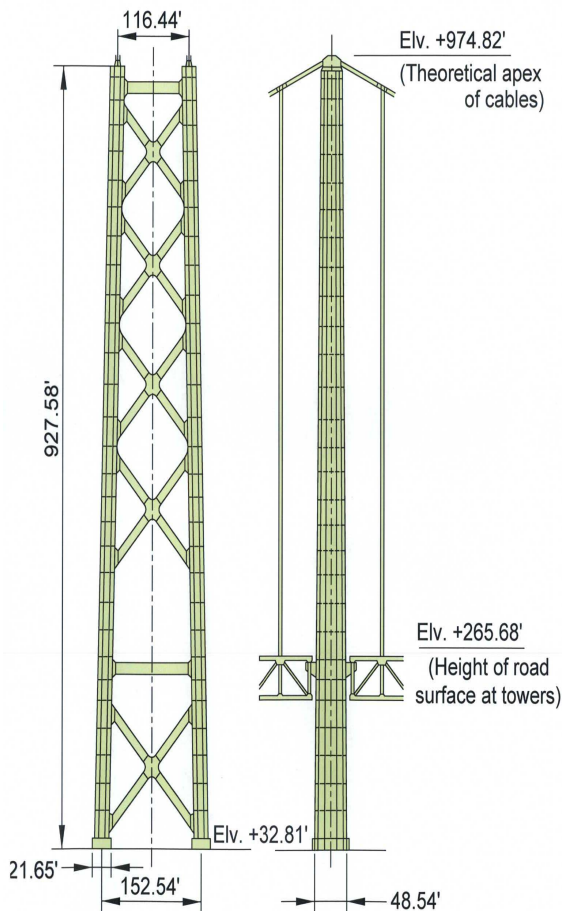
FIGURE 4: Each tower stitched together with 700,000 bolts

It was further explained that the all steel towers were erected using a free-standing, self climbing derrick that had a maximum lifting capacity of 176 short tons. The derrick was located midway between the two tower shafts and off-set in the longitudinal direction to allow the placing of the two shaft sections and the tower diagonals by the one derrick. Base-plates 27.22' wide and 54.12' long spread the cellular, cruciform tower shaft reactions through this 7" thick, steel slab. The shaft segments were stacked one on top of the other, in 31.8' lifts, thirty times. These lifts were divided into three sections according to their cellular cross-section to accommodate the 176 short ton, derrick, lifting capacity. These stacked steel lifts had to be leveled to within the tolerance of a 1/100", thick gap-gauge (Figure 4).

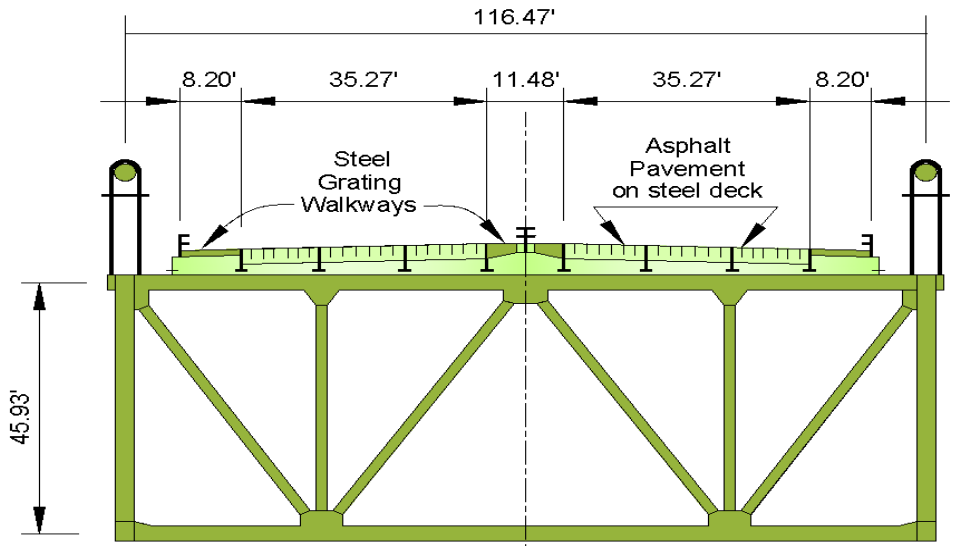
FIGURE 5: Typical section of the 100,000 short ton stiffening truss

damage was sustained. However, it was determined that pier P3 had moved 2'-7 1/2" along the alignment to increase the main span by that amount and the 4A anchorage had moved 10 3/8" along the alignment to also increase the side span by this amount. The stiffening truss (Figure 5) only required slight modification before the entire 100,000 short tons of steel was hung from the two main cables, after the quake, to complete the construction of the Pearl Bridge (Figure 6).

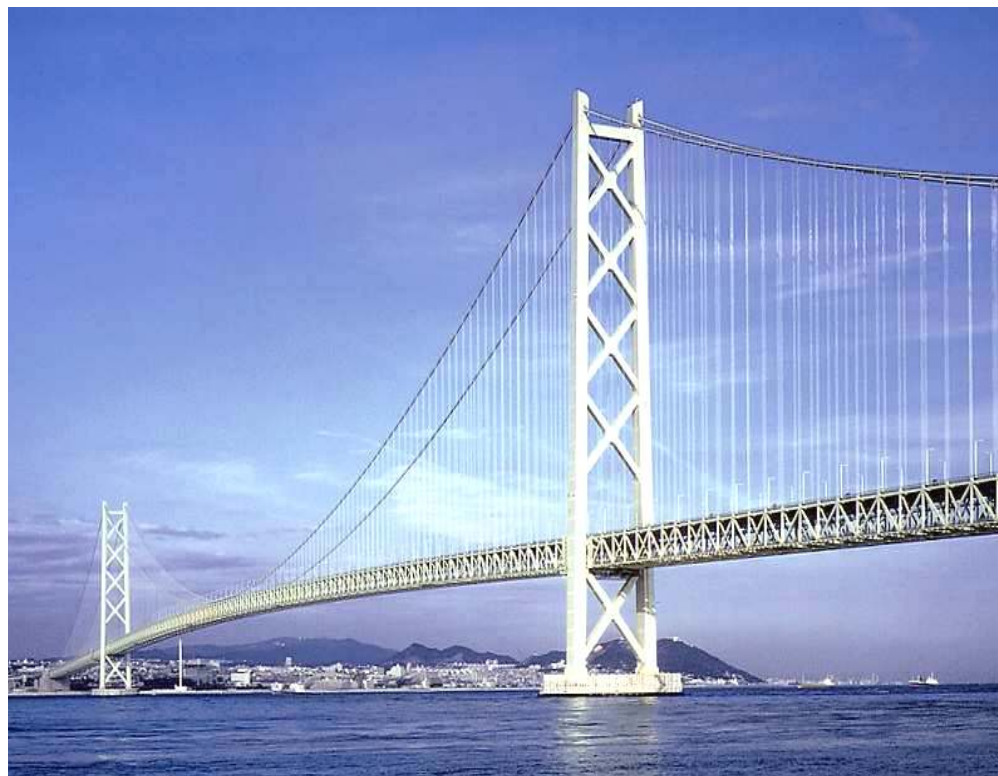
FIGURE 6: View of the resplendent Pearl Bridge in its distinctive green-gray coat

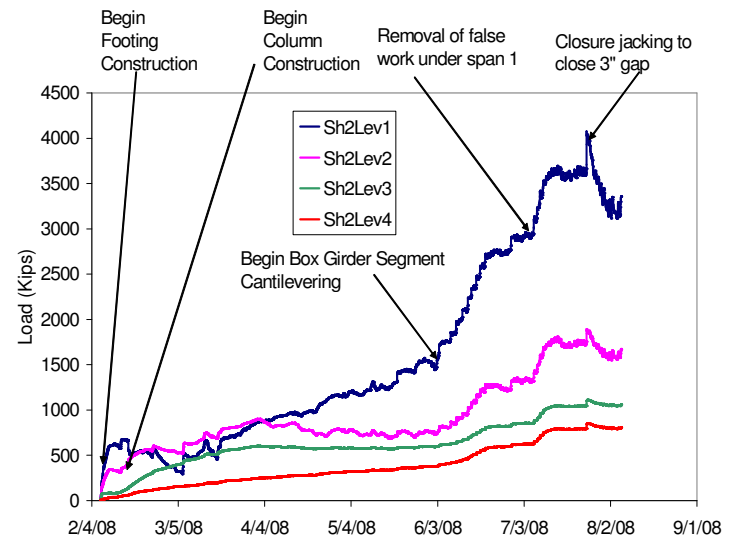
The attached graph (below) clearly charts the evolution of the construction loads and their accumulation onto the drilled shafts. Correspondingly, we can see how resistance to these loads is distributed: Sh2 Lev 1 (top of Drilled shaft) = 3200 kips; Sh2 Lev 2 = 1500 kips; Sh2 Lev 3 = 900 kips and Sh2 Lev 4 = 800 kips.

Each gauge level consisted of 4 vibrating wire (VW) strain gauges positioned at quarter points around the circumference of the shaft cross section. Two of the four VW gauges at each level were coupled with resistance type strain gauges which were situated at opposite sides of the shaft. This scheme capitalized upon the long term stability associated with VW strain gauges and their capability to take instantaneous readings from dynamic loading events.
